**25kV  
800 AMP Coupler and Adaptor  
Test Report**

## Test Report

**DEVICE TESTED:** AusProof 25 kV 800 A Coupler

Report Number: PL1792 25 kV Issue 3

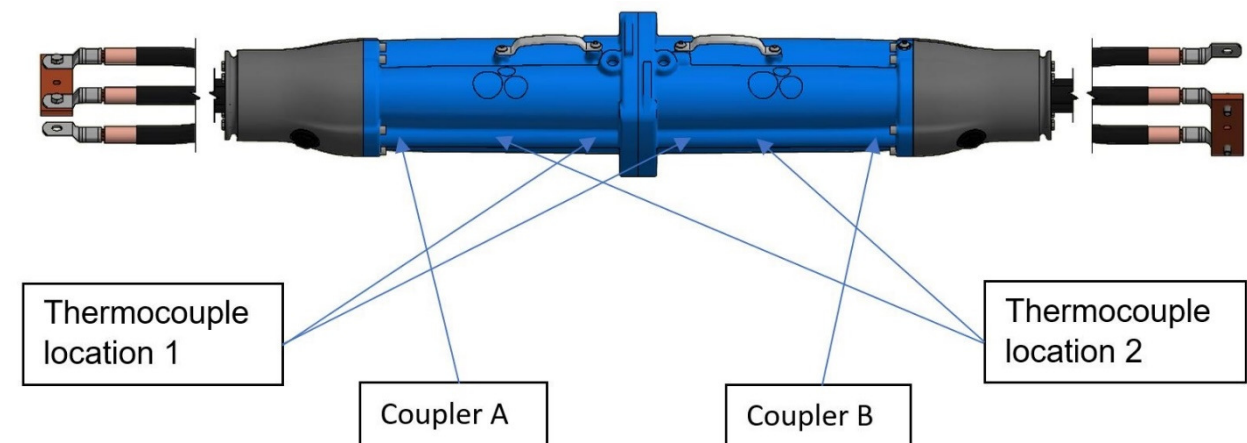
All conductors were connected in series and thermocouples were placed as required by Clause 3.3.8.4 of AS/NZS 1300.

Thermocouple locations included:

- (a) Main contact adjacent to connecting device (1)
- (b) Main contact adjacent to cable conductor (2)
- (c) Cable conductor 1 m from cable gland

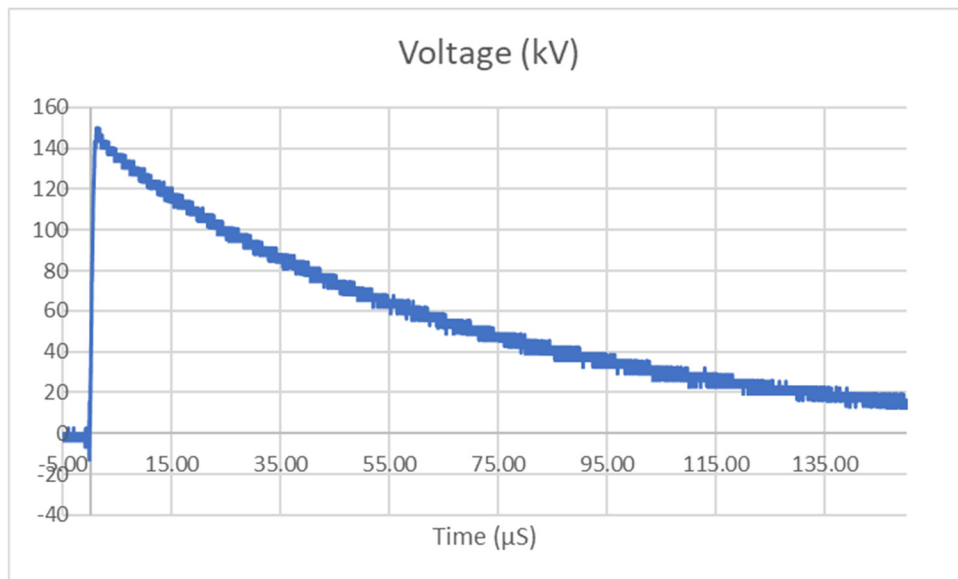
**Figure 1. Last 150 kV impulse**

Wave shape was 1.0/44  $\mu$ s. Refer to Figure 1.

During the application the 150 kV impulses no disruptive discharges, flashovers or insulation punctures were noted.  
Refer to Figure 1.

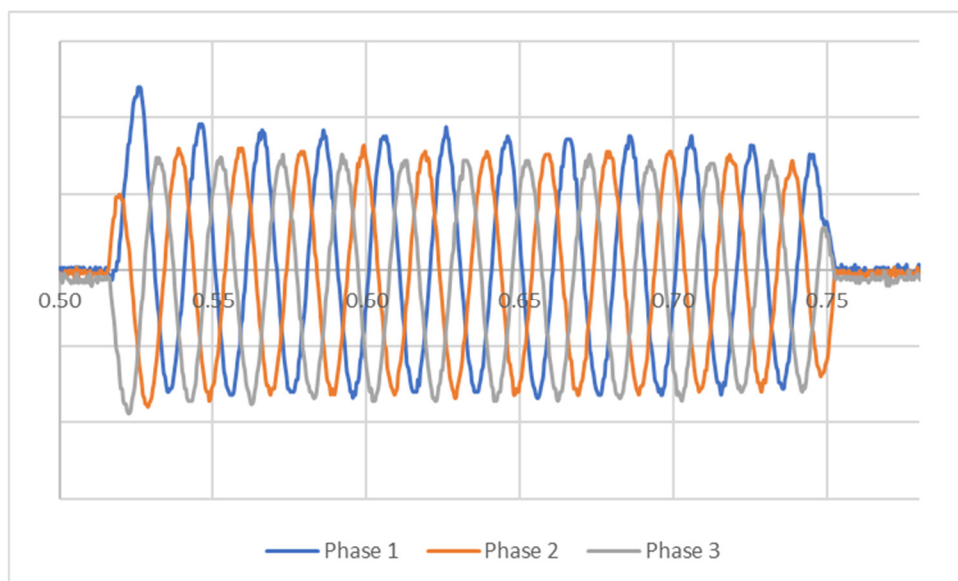
**Figure 2. 20 kA for 0.2 s short circuit test number 3**

Results: 0.234 s, 19.8 kA, n=2.0 (power factor = 0.3), 50 Hz, mean of 3 tests applied with 10 minutes between. Refer to Figure 2.

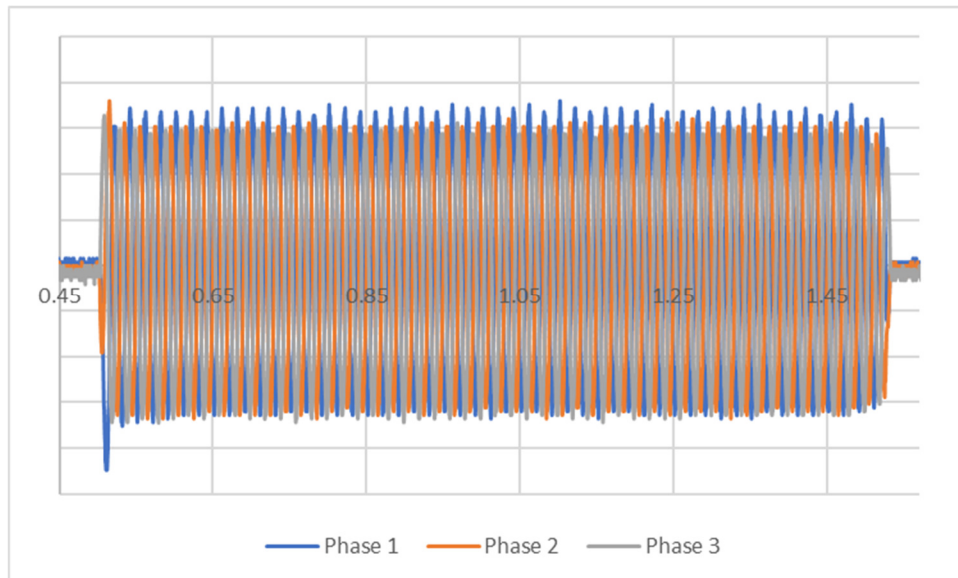
**Figure 3. 20 kA for 1 s short circuit test**

Results: 1.03 s, 19.7 kA, n=2.0 (power factor = 0.3), 50 Hz. Refer to Figure 3.

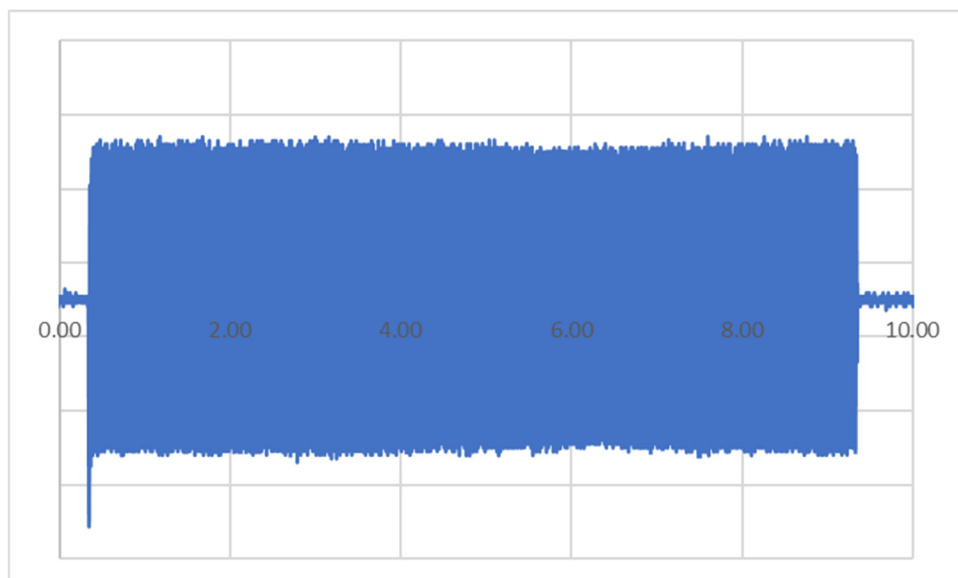
**Figure 4. 5 kA for 9 s short circuit test**

Results: 9.08 s, 5.13 kA, n=2.0, 50 Hz. Refer to Figure 4.

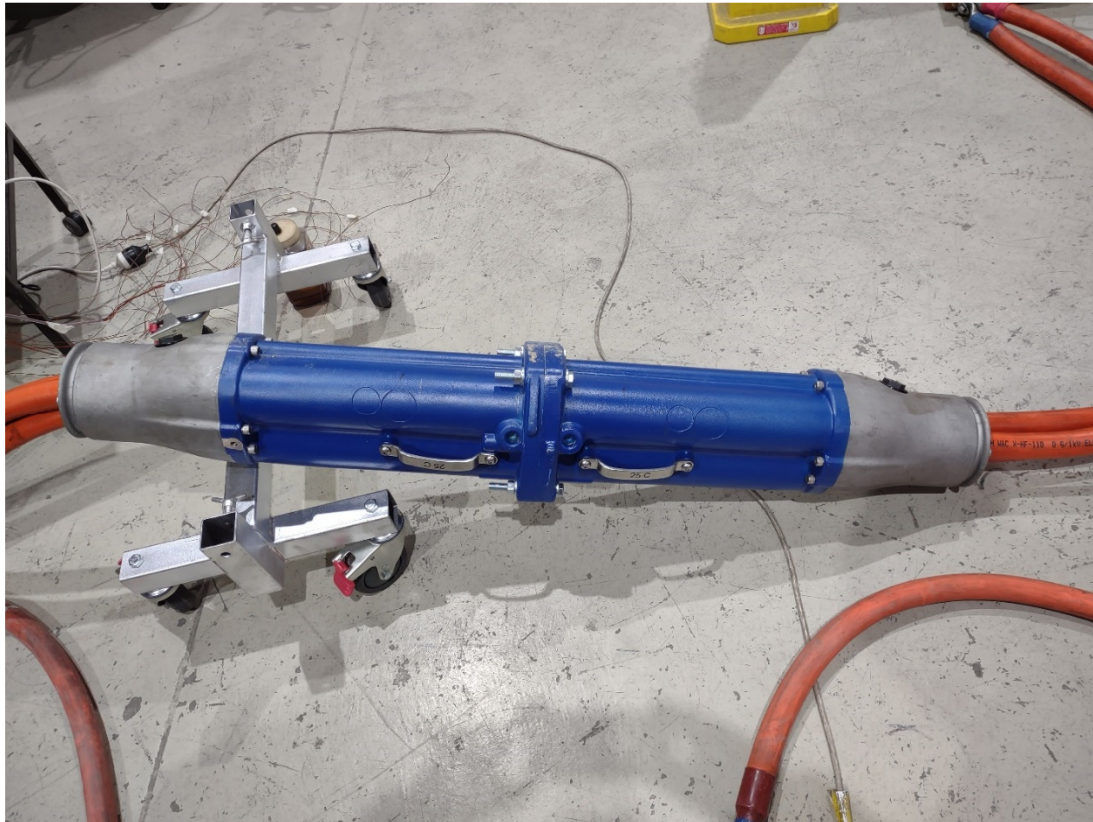
Picture 1 General view of coupler

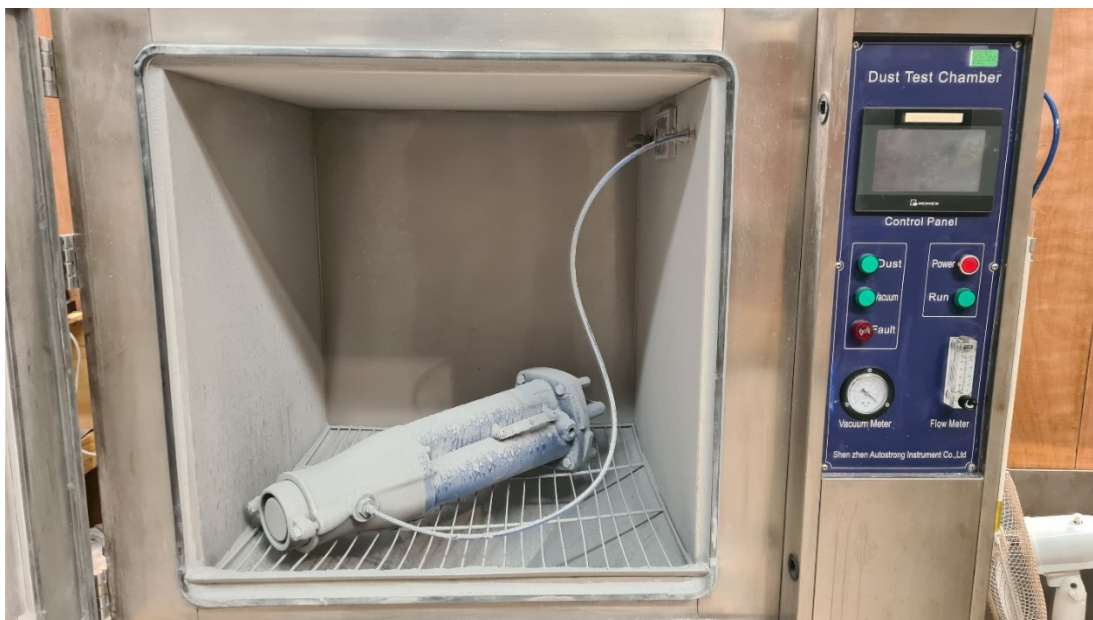
Picture 2 Coupler in dust test

| CI 13.6 | Ingress of Dust Test (AS 60529) | | | | P |
|---|---|---|---|---|---|
| Unit 1 | IP6X | 6.1 | 15.1 | 24.4 | P |
| Unit 2 | IP6X | 6.1 | 15.0 | 20.9 | P |

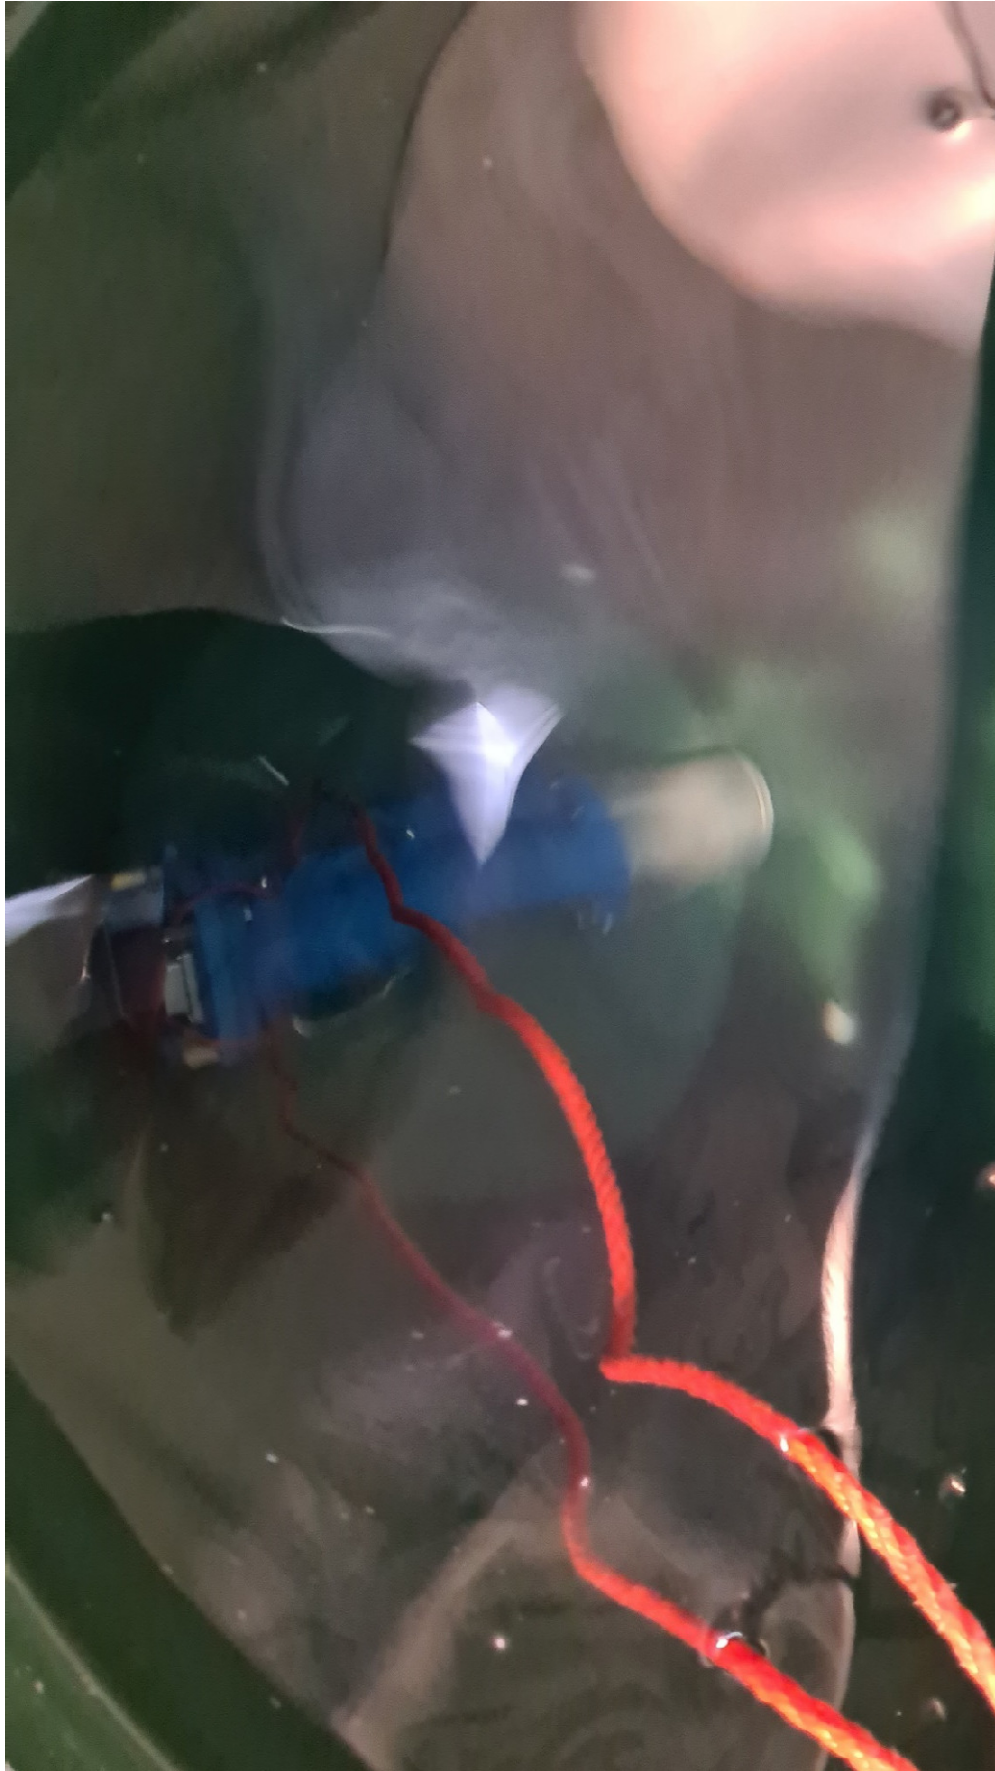
Picture 3 Coupler in 1 m water

| CI 14.3 | Ingress of Water Test (AS 60529) | | | | | P |
|---|---|---|---|---|---|---|
| Unit 1 | IPX8 | 1.1 | 60.0 | 15.0 | 17.4 | P |
| Unit 2 | IPX8 | 1.1 | 60.0 | 15.4 | 16.4 | P |

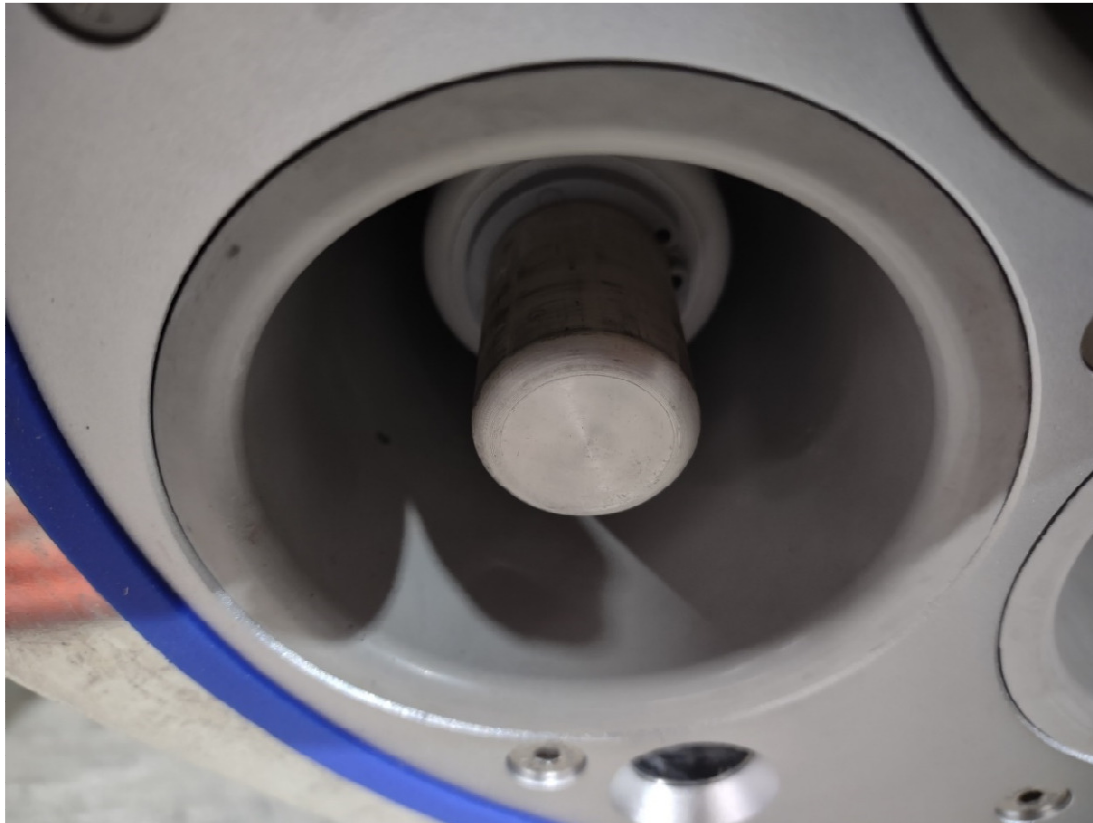
Picture 4 Contacts after short circuit test

After current applications, there were no visible disturbance, pitting or burning.

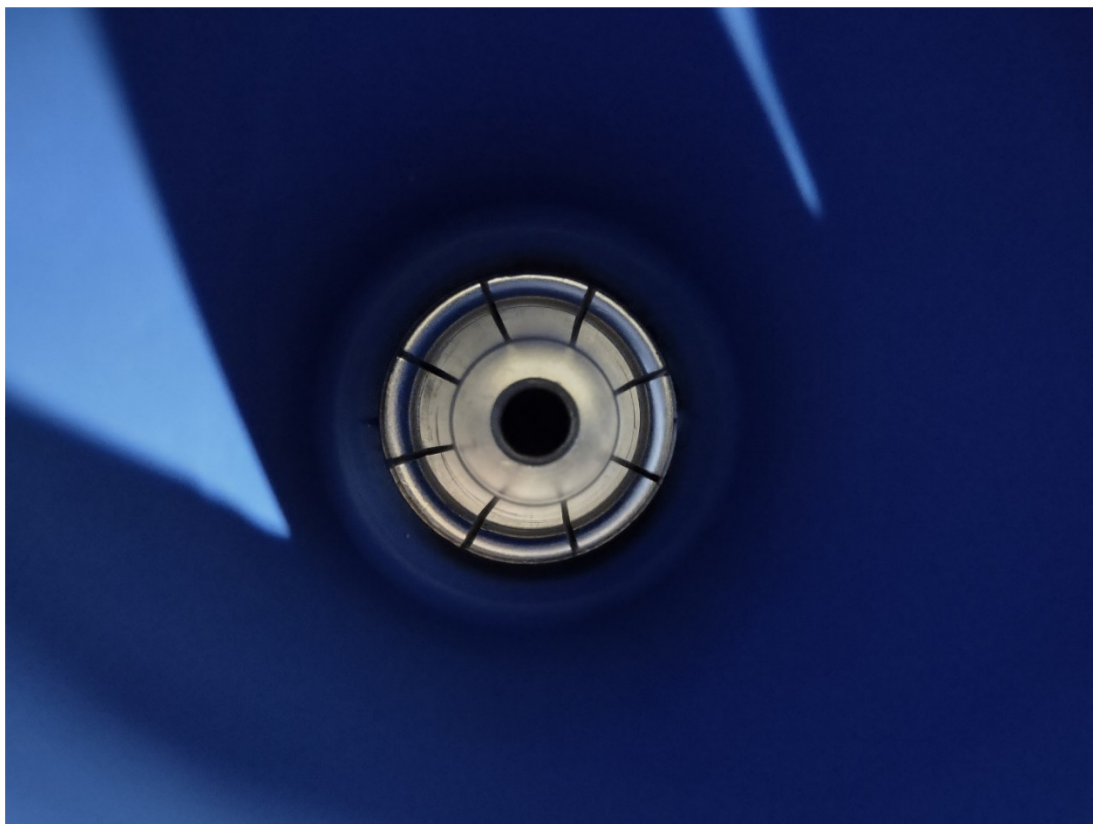
Picture 5 Contacts after short circuit test
