# 11kV / 15kV 800 AMP Coupler and Adaptor Test Report

# **Test Report**

DATE ISSUED:	11 November 2023
DEVICE TESTED:	AusProof 11 kV / 15 kV 800 A Coupler
RANGE NUMBERS:	114BKA, 118BKA, 15BU, 15BUMT, 15BUMTE, 15BUFO
CLIENT'S NAME:	AusProof Pty Ltd 6 Shona Avenue Gladstone Queensland 4680 Australia
CLIENT'S REFERENCE:	Email: Clinton Taylor
TEST SPECIFICATION:	Client specification including references to AS/NZS 1300, AS/NZS 1299, C22.2 No 298, AS/NZS 1802, AS/NZS 2802, IEEE 386 and IEEE 404
DATE OF TEST COMPLETION:	22 November 2022
SUMMARY OF RESULTS:	The sample device tested complied with the requirements of the above test specification.

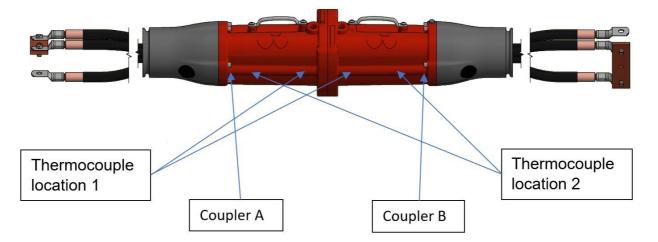
All conductors were connected in series and thermocouples were placed as required by Clause 3.3.8.4 of ASNZS 1300.

Thermocouple locations included:

- (a) Main contact adjacent to connecting device (1)
- (b) Main contact adjacent to cable conductor (2)
- (c) Cable conductor 1 m from cable gland

Location	Coupler	Thermocouple location	Phase ID
А	А	1	White
В	А	2	White
С	А	1	Blue
D	А	2	Blue
E	А	1	Red
F	А	2	Red
G	В	1	Blue
Н	В	2	Blue
	В	1	Red
J	В	2	Red
К	В	1	White
L	В	2	White

Location	A	В	С	D	E	F	G	Н	I	J	K	L
Rise	33.2	30.7	34.0	31.1	30.6	34.7	33.1	30.4	32	32.3	34.4	31.3
Difference from cable	8.4	5.9	9.2	6.3	5.8	9.9	8.3	5.6	7.2	7.5	9.6	6.5
