### 6.6kV / 8.7kV 800AMP Coupler and Adaptor Test Report

#### **Test Report**

DATE ISSUED: 12 January 2024 DEVICE TESTED: AusProof 6.6 kV / 8.7 kV 800 A Coupler **RANGE NUUMBERS:** 64BKA, 64BKAFO, 64BKAE, 8BU, 8BUFO, 8KA, 8KAFO, 8KAKEY, 8KAMT 8KAMTE, 8KAE **CLIENT'S NAME:** AusProof Pty Ltd 6 Shona Avenue Gladstone **Queensland 4680** Australia **CLIENT'S REFERENCE:** Email: Clinton Taylor **TEST SPECIFICATION:** Client specification including references to AS/NZS 1300, AS/NZS 1299, C22.2 No 298, AS/NZS 1802, AS/NZS 2802 and IEEE 404 DATE OF TEST COMPLETION: 23 December 2022 SUMMARY OF RESULTS: The sample device tested complied with the

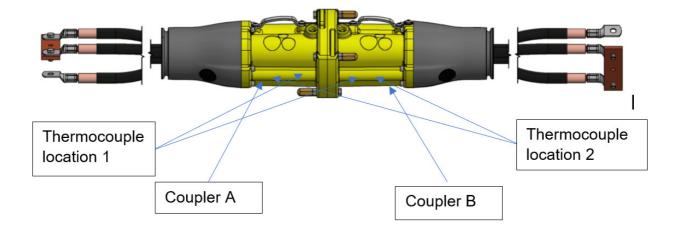
All conductors were connected in series and thermocouples were placed as required by Clause 3.3.8.4 of ASNZS 1300.

Thermocouple locations included:

- (a) Main contact adjacent to connecting device (1)
- (b) Main contact adjacent to cable conductor (2)
- (c) Cable conductor 1 m from cable gland

Location	Coupler	Thermocouple location	Phase ID
А	А	1	White
В	А	2	White
С	А	1	Blue
D	А	2	Blue
E	А	1	Red
F	А	2	Red
G	В	1	Blue
Н	В	2	Blue
1	В	1	Red
J	В	2	Red
K	В	1	White
L	В	2	White

Location	A	В	С	D	E	F	G	Н	I	J	K	L
Rise	40	38	40	36	37	39	37	38	37	37	42	39
Difference from cable	9	7	8	5	5	8	6	7	6	5	10	8

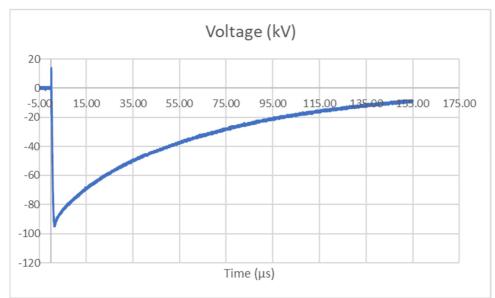
Wave shape was 1.0/43 µs. Refer to oscillogram included in this report

During the application the 95 kV impulses no disruptive discharges, flashovers or insulation punctures were noted. Refer to Figure 1.

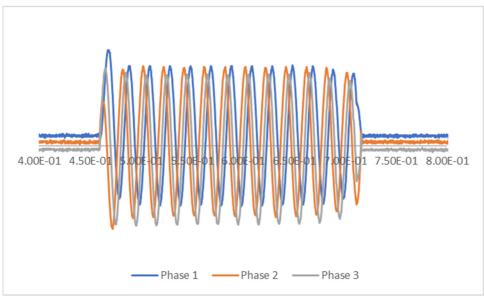
Figure 2. 20 kA for 0.2 s short circuit test number 3

Results: 0.22 s, 21.8 kA, n=2.0 (power factor = 0.3), 50 Hz, mean of 3 tests applied with 10 minutes between. Refer to Figure 2.

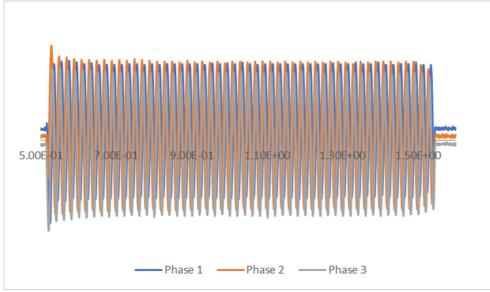
Figure 3. 20 kA for 1 s short circuit test

Results: 1.03 s, 20.8 kA, n=2.0 (power factor = 0.3), 50 Hz. Refer to Figure 3.

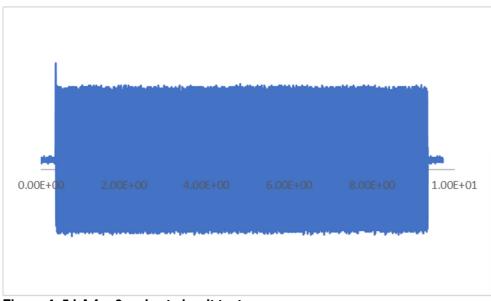
Figure 4. 5 kA for 9 s short circuit test

Results: 9.3 s, 5.0 kA, n=1.9, 50 Hz. Refer to Figure 4.

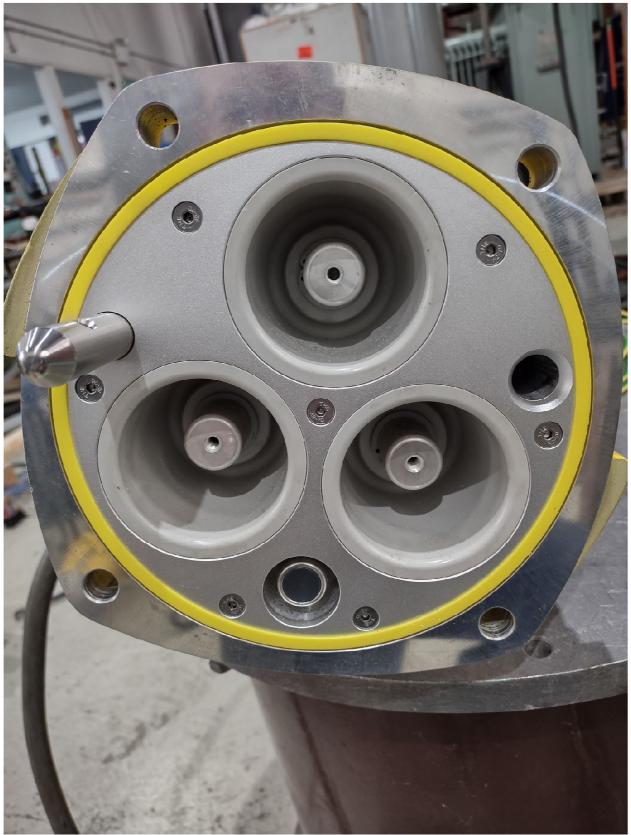
Picture 2 View of main contacts

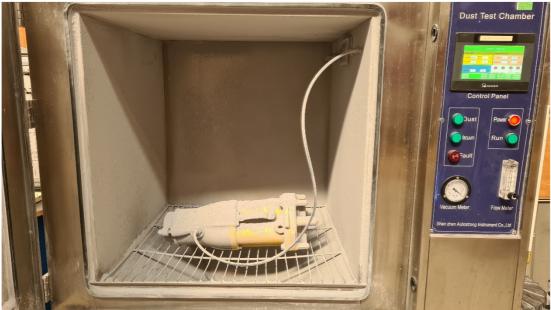
Picture 3 Coupler in dust test

CI 13.6	Ingress of Dust Test (AS 60529)						
EUT Degree of protection (Dust)		Duration of test (hr)	Ambient temperature (°C)	EUT ambient (°C)	Verdict		
Unit 1		IP6X	2.6	24.6	31.9	Р	
Unit 2		IP6X	2.6	22.6	29.6	Р

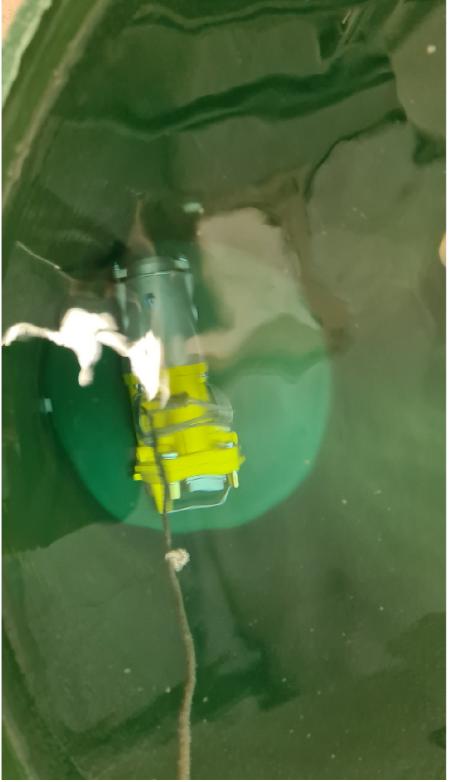
Picture 4 Coupler in 1 m water

CI 14.3	Ingre	Ingress of Water Test (AS 60529)							
EUT identification Degree of protection (Water)		Depth of EUT from surface (m)	Duration of test (min)	Ambient temperature (°C)	Water Ambient temperature (°C)	Verdict			
Unit 1		IPX8	1.0	60.0	23.8	22.2	Р		
Unit 2		IPX8	1.0	60.0	23.0	22.8	Р

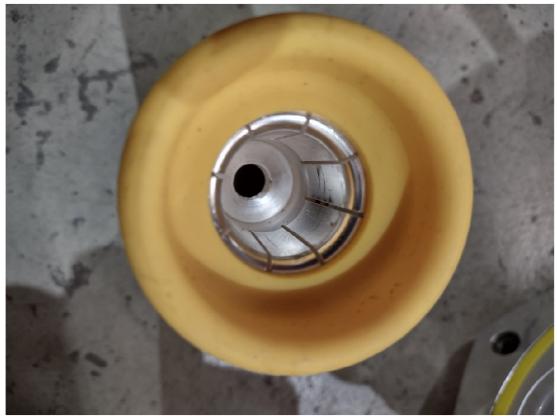
Picture 5 Contacts after short circuit test

After current applications, there were no visible disturbance, pitting or burning.

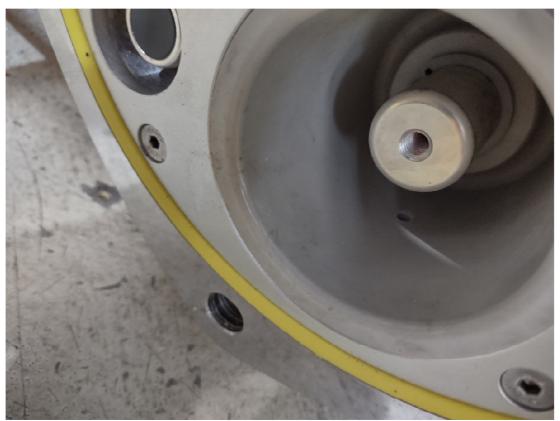
Picture 6 Contacts after short circuit test
